Briarwood Detention Pond Repairs

October 15, 2015

The preliminary estimate for engineering and construction to repair the damaged South Detention Pond structures is \$11,000. This document provides a brief description of the Briarwood Detention Ponds location, purpose and current Issues.

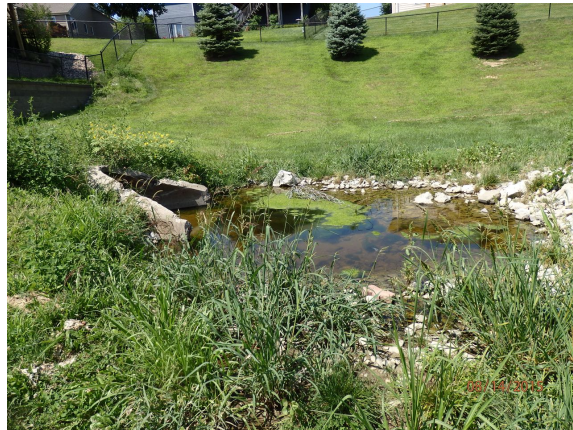
Collapsed Inlet South Pond

Sediment has accumulated over the almost 15 years since construction, especially around the inlet discharge pipes on the South Pond. The sediment has increased to the bottom of the pipe, the pipe support has been eroded, a section of pipe has tilted, and the resulting water jet erodes a hole leaving a pool of water. The hole and retained water fills with algae which becomes odorous in the summer months and a potential insect-breeding place.

While the minimum volume has not been compromised, construction will be required to remove excess sediment, provide a suitable discharge pipe support, replace the damaged discharge pipe section, and replace the discharge energy absorbing "scour hole" structure.
