Briarwood Detention Pond Repairs

October 15, 2015

The preliminary estimate for engineering and construction to repair the damaged South Detention Pond structures is \$11,000. This document provides a brief description of the Briarwood Detention Ponds location, purpose and current Issues.

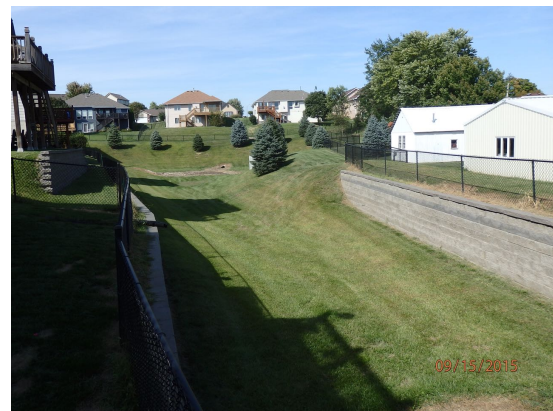
South Detention Pond

Sediment has accumulated over the almost 15 years since construction, especially around the inlet discharge pipes on the South Pond. The sediment has increased to the bottom of the pipe, the pipe support has been eroded, a section of pipe has tilted, and the resulting water jet erodes a hole leaving a pool of water. The hole and retained water fills with algae which becomes odorous in the summer months and a potential insect-breeding place.

While the minimum volume has not been compromised, construction will be required to remove excess sediment, provide a suitable discharge pipe support, replace the damaged discharge pipe section, and replace the discharge energy absorbing "scour hole" structure.
